**Mayor's Award
Pat Fishback
"Overall Restoration"
610 Third Street**

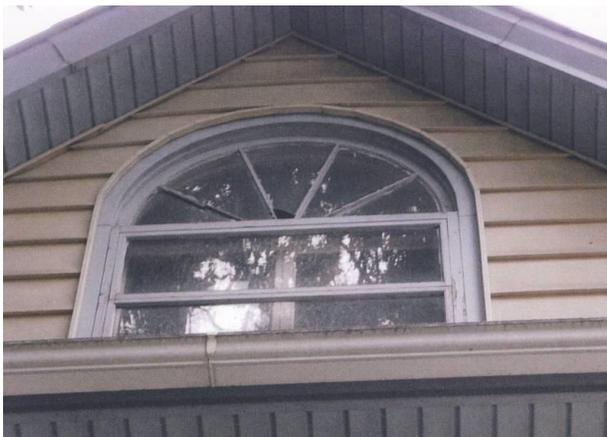
With vinyl siding intact

610 3rd Street has gone unnoticed for years until recent historic preservation work has brought a new life and character to this beautiful home that was built in 1910. Pat Fishback with the help of Mark Kelsey and his crew uncovered a myriad of treasures in this century-old home. Renovations began with removal of the vinyl siding, which revealed preserved intact fish scale decorative shingles. Vinyl siding often exacerbates rot of underlying wood materials, so it was fortunate the wood ornamentation survived.

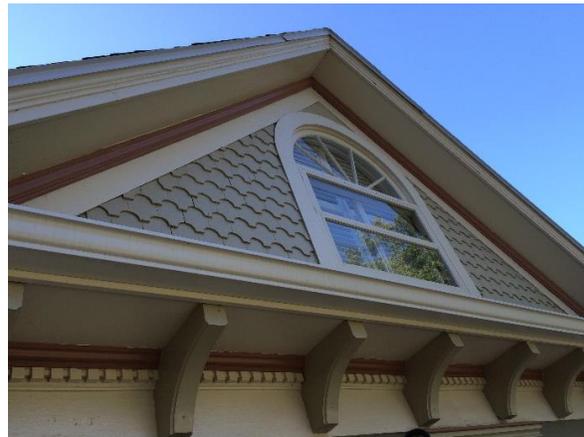
With siding gone – showing fish scale shingles

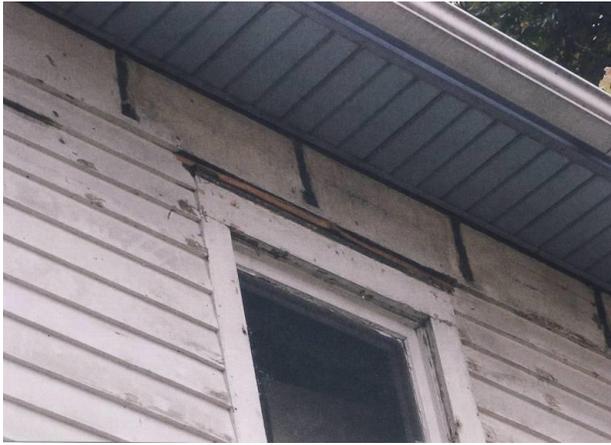
Corbel bracket shadows

Another discovery was the shadow of what once was roof corbel brackets. These decorative elements lined the roof on three sides of the structure. While none of the originals brackets could be found, 44 new corbels were locally recreated based on the extant evidence.

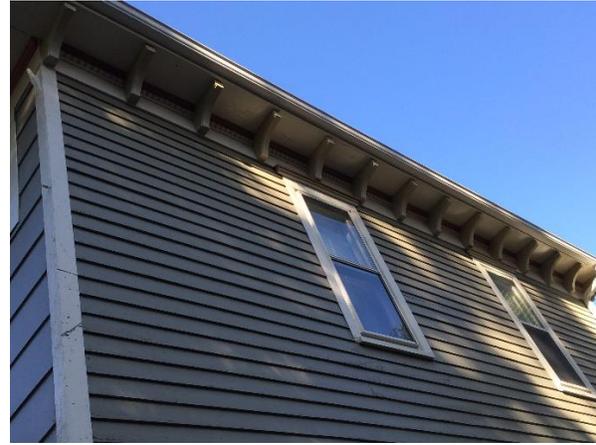
New corbels

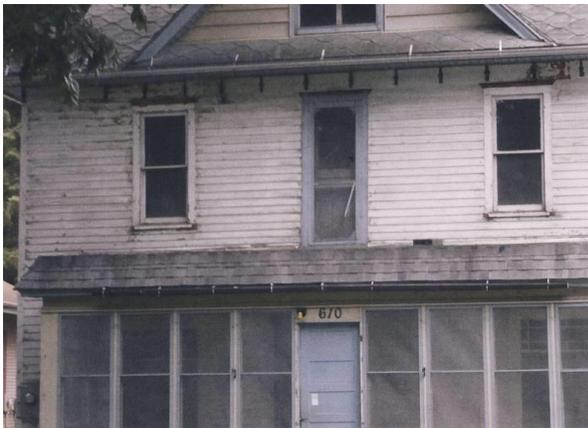
Old enclosed porch

The once open porch was enclosed long ago, which was common porch modification during the Twentieth Century. The original plan was to rebuild the extensively deteriorated enclosed porch. However, as work crews began removing parts of the porch they made interesting discoveries. First, they revealed three generally well-preserved posts from the original porch. Then 122 holes were detected in porch top rails, marks left by previously removed decorative spandrels that had graced the original porch. With these discoveries, the plan changed to renovate the porch to its original open grandeur.

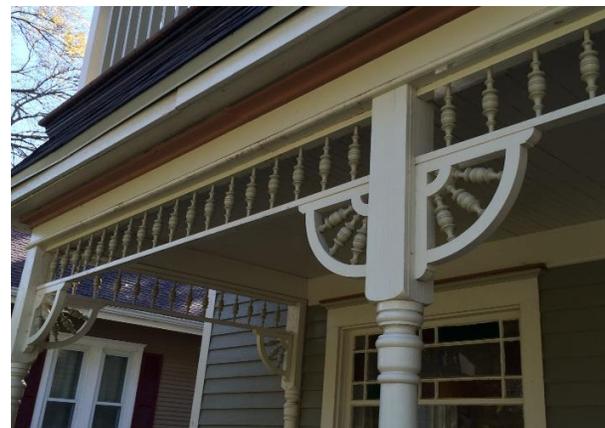
New posts and decorative spandrels

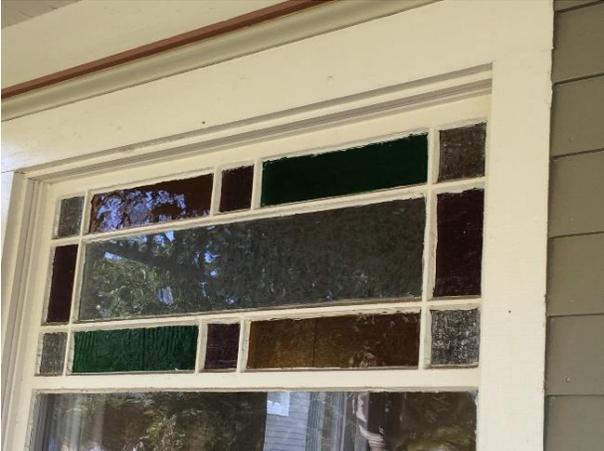
Stained glass windows on front side of house

Rehabilitation work began June 2014 and was finished October 2015. This essentially five-bedroom, three-bath house was restored with the original flooring, new roof, new HVAC, new electrical system, modern kitchen, updated patio and landscaping. The addition space has been creatively reconfigured including the placement of windows while retaining the integrity of the original house. Original stain glass windows are intact at the front of the house.
